**Site and Reach Assessment  
SR 530 Sauk-Suiattle Confluence at MP 55.5  
Chronic Environmental Deficiency Site**

**Jim Park, Senior Hydrologist  
Rob Schanz, Hydrologist  
WSDOT Environmental Services  
Hydrology Program**

**September 2014**

**Washington State Department of Transportation**  
Environmental and Engineering Service Center  
Environmental Services Office

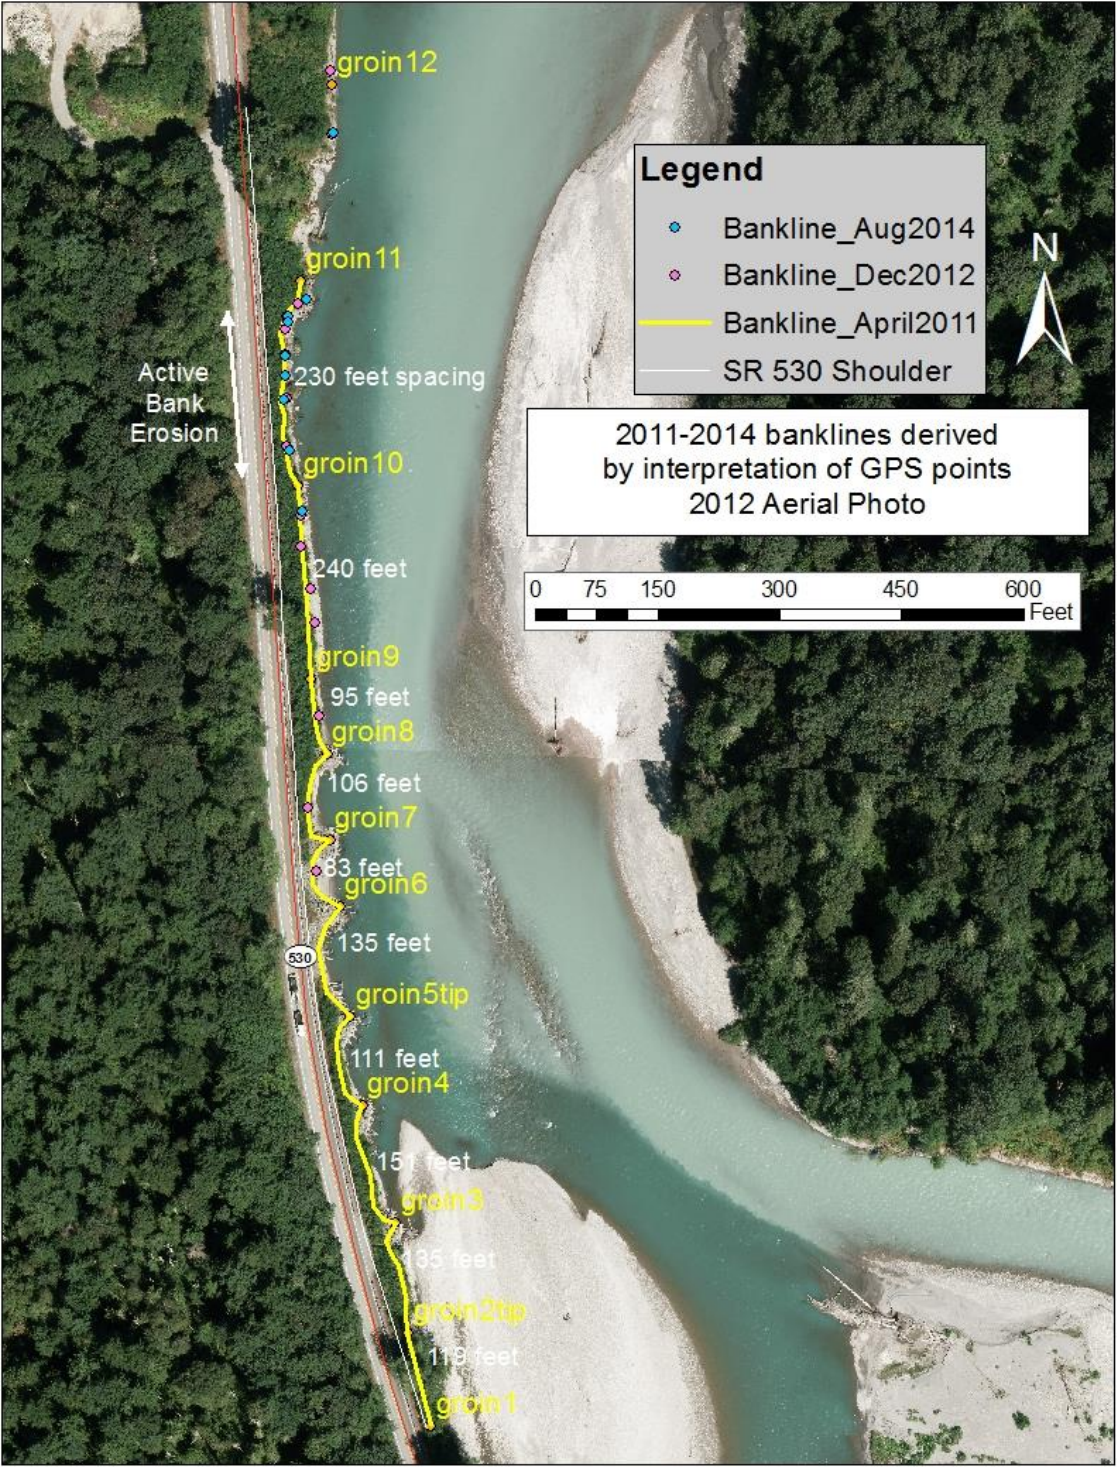
Figure 2a. Locations of groins and banklines in April 2011, December 2012, and August 2014.

WSDOT determined that this erosion posed a severe and imminent threat to SR 530, and in 2008 constructed twelve groins buried in the bank (Figure 2a). The groins were made up of angular rock and approximately 90 pieces of embedded large woody material (LWM). The design was developed to ensure prompt regulatory approval that would enable construction prior to high flows in the river. WSDOT understood that the length of some of the groins and the distance between them could result in erosion between the groins that would extend into a portion of the road prism. However, there was a potential for catastrophic loss of the entire road prism had WSDOT not taken action, and this was determined to outweigh the risk.

Groins 1 and 2 are located just upstream of the confluence and have not yet been exposed by erosion. High flows in the winter after construction exposed six of the shortest groins (Groins 3 to 8) and eroded between them to the edge of the road prism. These groins were subsequently extended to increase protection of areas between the groins. Eroded areas between the groins were reinforced with rock and LWM. A total of 66 additional pieces of LWM were incorporated into the project at this time. Geomorphic monitoring reports in 2010 and 2011 observed sand deposition, wood recruitment, and stable banks between most of these repaired groins. The area between Groins 7 and 8 did not receive new wood placements and therefore experienced additional bank erosion and failure of rock riprap.

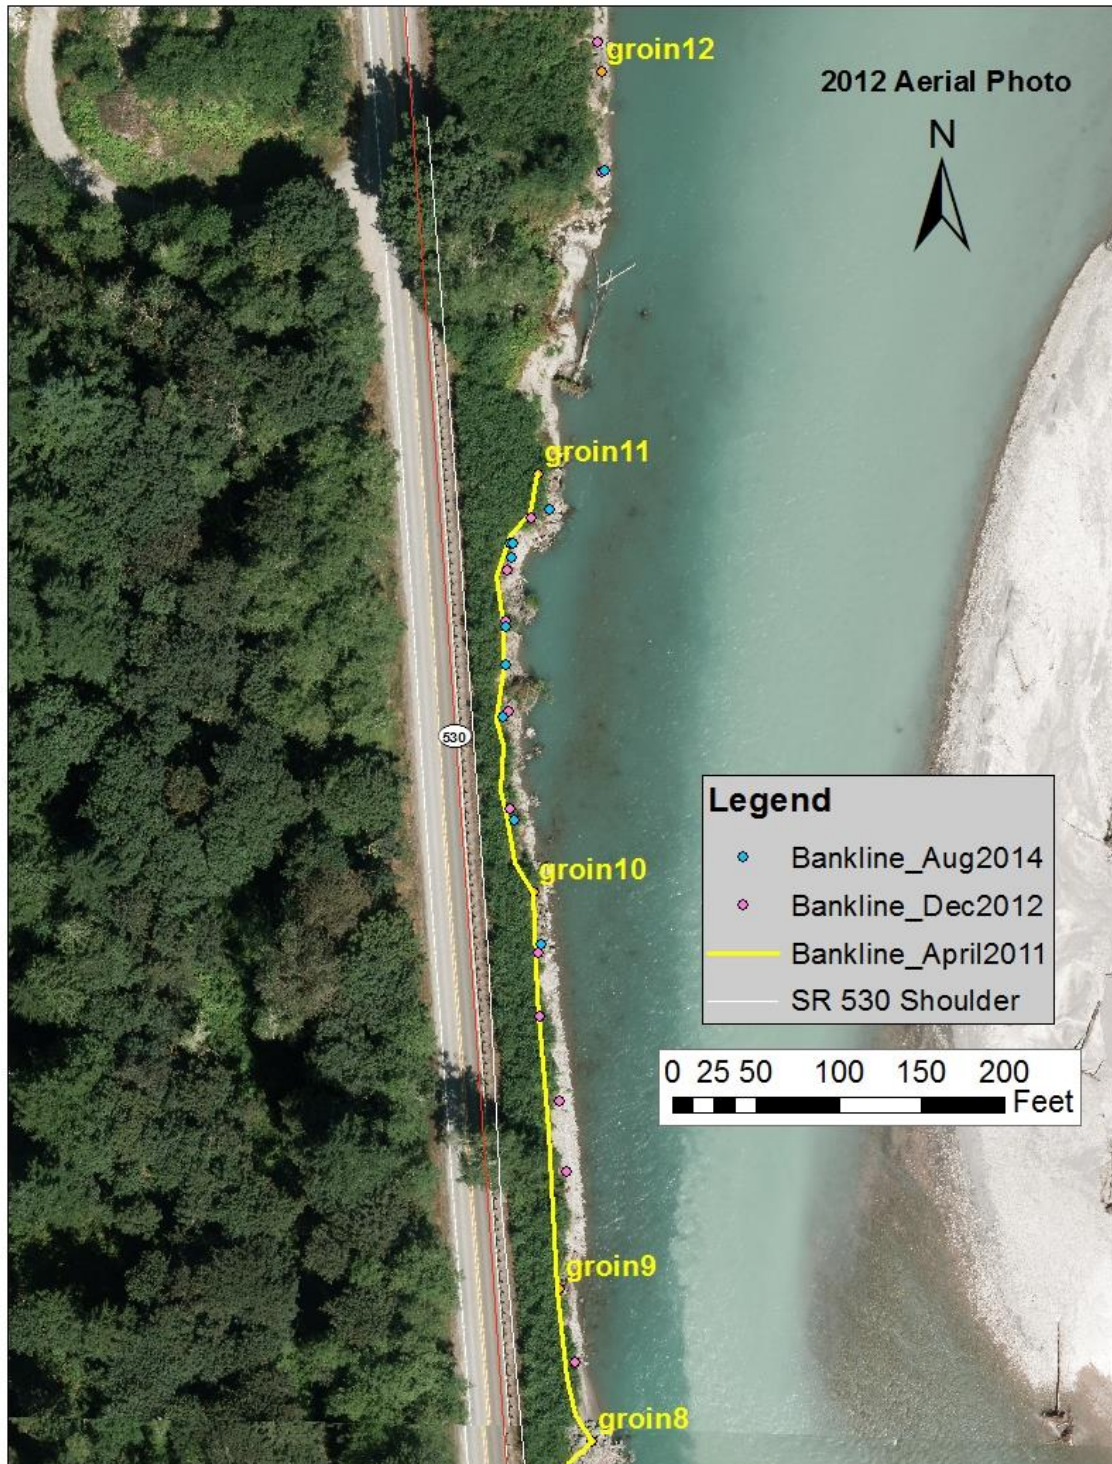
Figure 2b. April 2011, December 2012, and August 2014 bank measurements between Groins 8 and 12.

We observed no major changes in the condition of the bank during site visits in December 2012 and August 2014, aside from some undermining of riparian vegetation downstream of Groin 8. Figures 2a and 2b compare GPS bankline measurements from 2011, 2012, and 2014. No major floods occurred in this period.

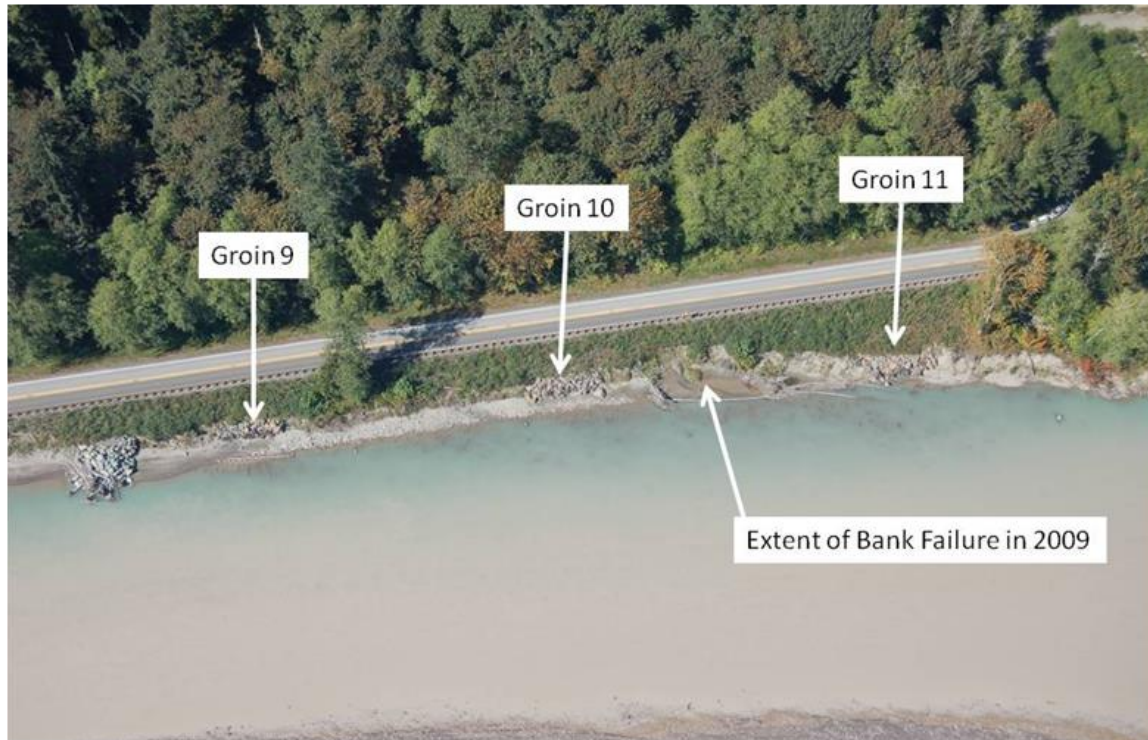
Aerial photos from September 2009 show the onset of new erosion near Groin 10 at the downstream end of the repair site. By April 2011 this erosion had progressed to within 20 feet of the road shoulder and was occurring in most of the bank between Groins 10 and 11. The 2011 Geomorphic Monitoring Report concluded that Groins 9-11 were spaced too far apart to effectively protect the bank, and recommended adding two new groins (WSDOT, 2011). The report also recommended extending Groins 9 and 10 and adding rock armor and LWM to the toe of the bank between Groins 10 and 11, similar to repairs previously done for upstream groins. These recommendations have not yet been implemented.

**Figure 3. Initiation of bank failure near Groin 10, September 2009 aerial photo.**

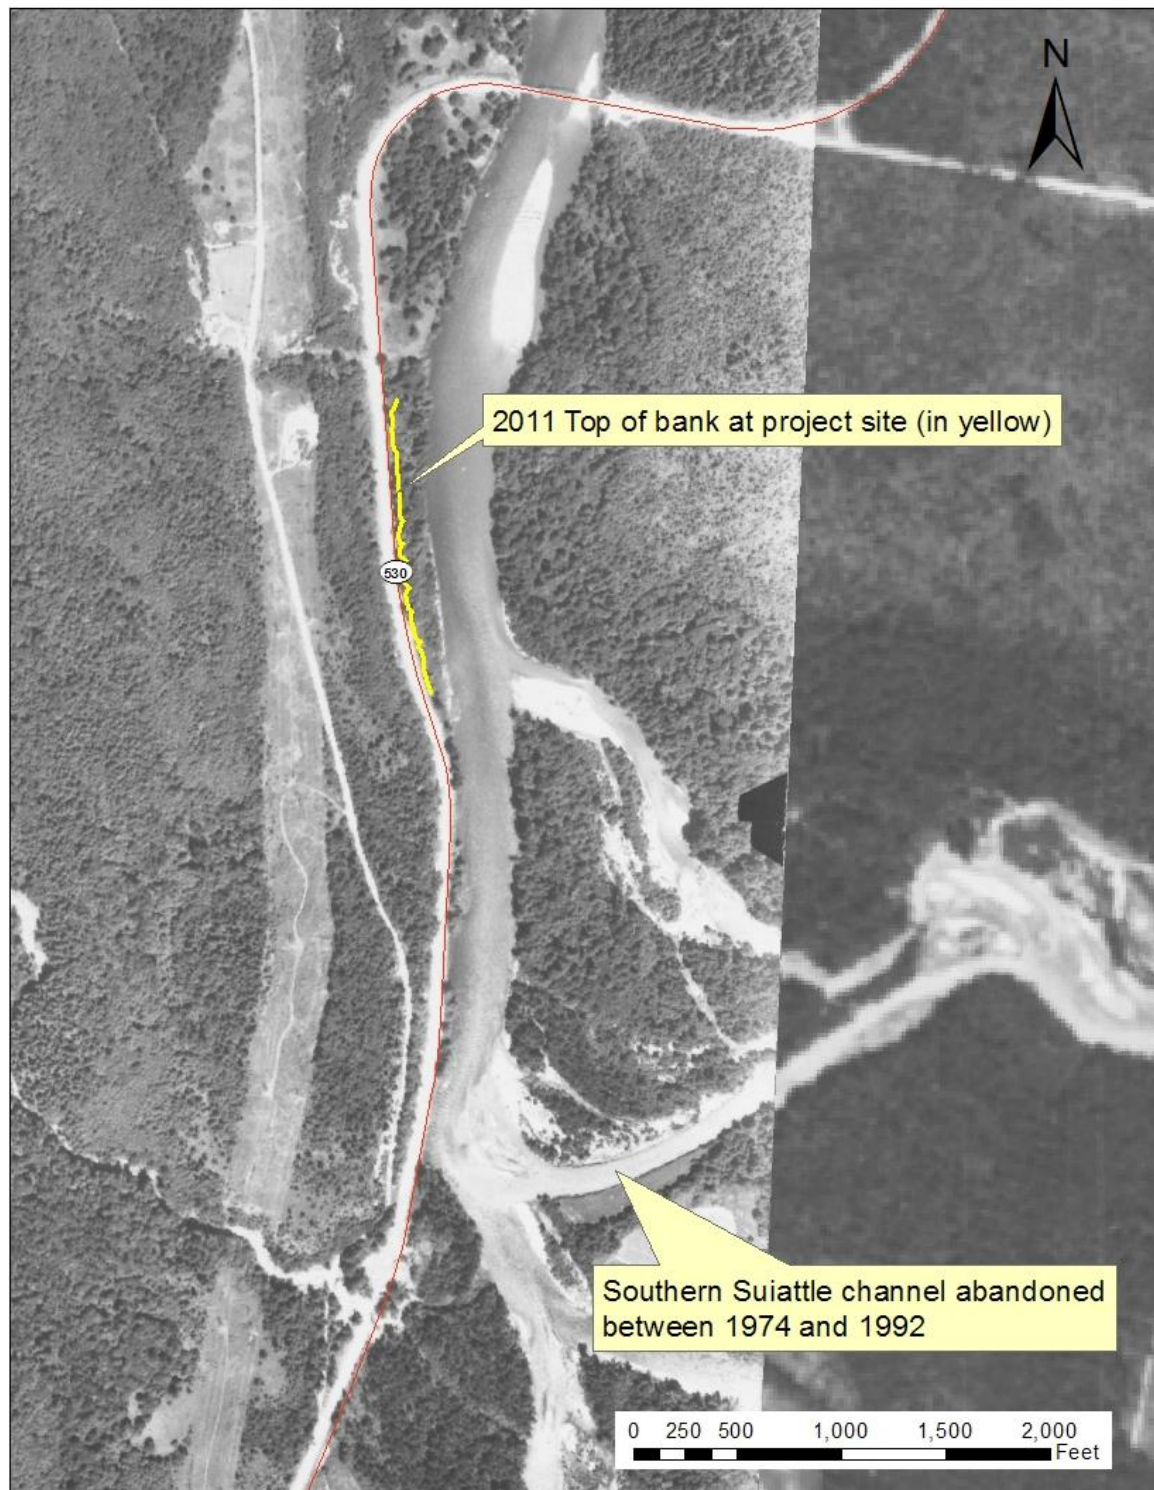
Historical aerial photos illustrate the dynamic nature of the confluence. In 1964 the Suiattle split between the current confluence and a larger channel located about 2300 feet to the south of the project site (Figure 4). SR 530 at the project site was separated from the river at this time by more than 100 feet of riparian forest. The southern channel was abandoned sometime between 1974 and 1992, and all of the Suiattle's flow is now concentrated in a braided channel that enters the Sauk just opposite of the project site (Figure 5). This has caused the river to steadily erode into the riparian terrace that once buffered the highway from the river.

**Figure 4. Configuration of the Sauk-Suiattle confluence in 1964.**

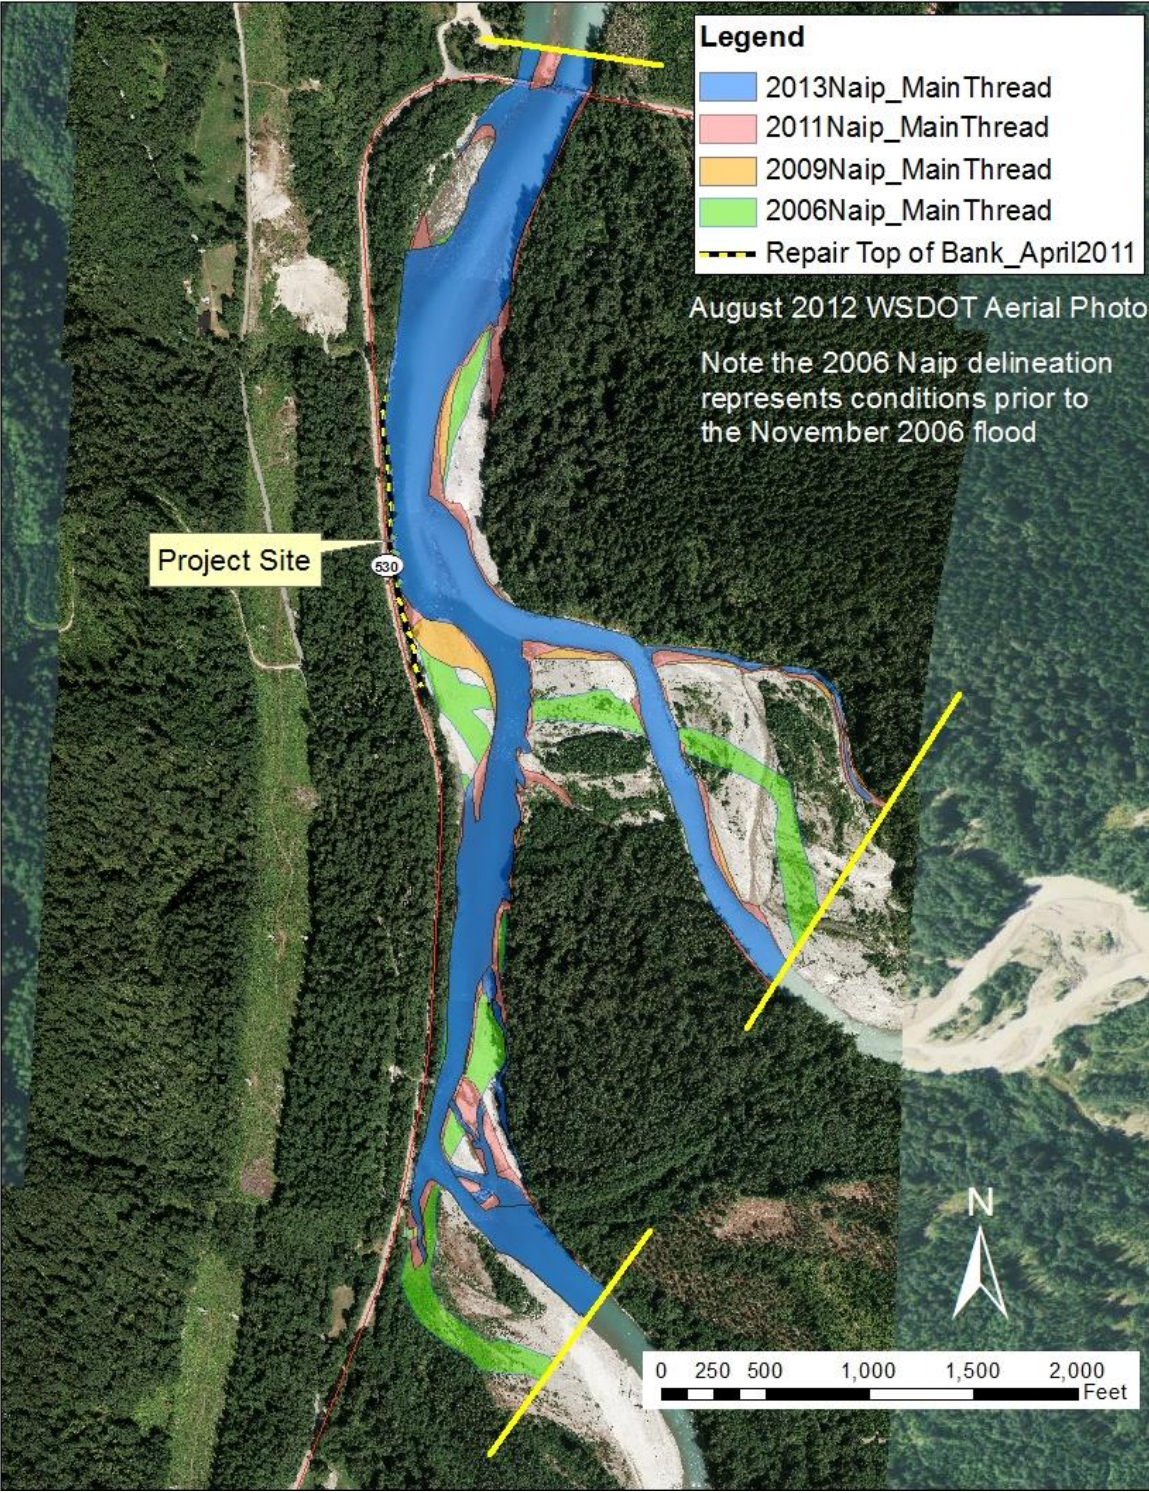
Figure 5 shows recent changes in the configuration of the confluence that have increased the erosion problem. After the November 2006 flood the Suiattle shifted northward to enter the Sauk at a near perpendicular angle of attack directly opposite the upstream end of the site. This increased flow curvature and shear stresses against the upstream end of the site where erosion problems were concentrated prior to the 2008 repair. The 2006

flood also brought sediment into the system that led to steady growth of a sediment bar opposite the site, narrowing the channel and bringing more energy against the left bank.

Between 2009 and 2011 flow patterns shifted to bring more erosive energy against the downstream end of the site (near groins 9, 10, and 11). A new sediment bar built up on the left bank just upstream of the site, pushing the Sauk into an S-curve through the confluence. As it merges with the Suiattle the Sauk then bends sharply against the downstream end of the site. The right bank bar has also continued to grow downstream of the confluence, especially opposite groin 10.

Figure 5. Channel patterns shown in aerial photos from 2006-2013.

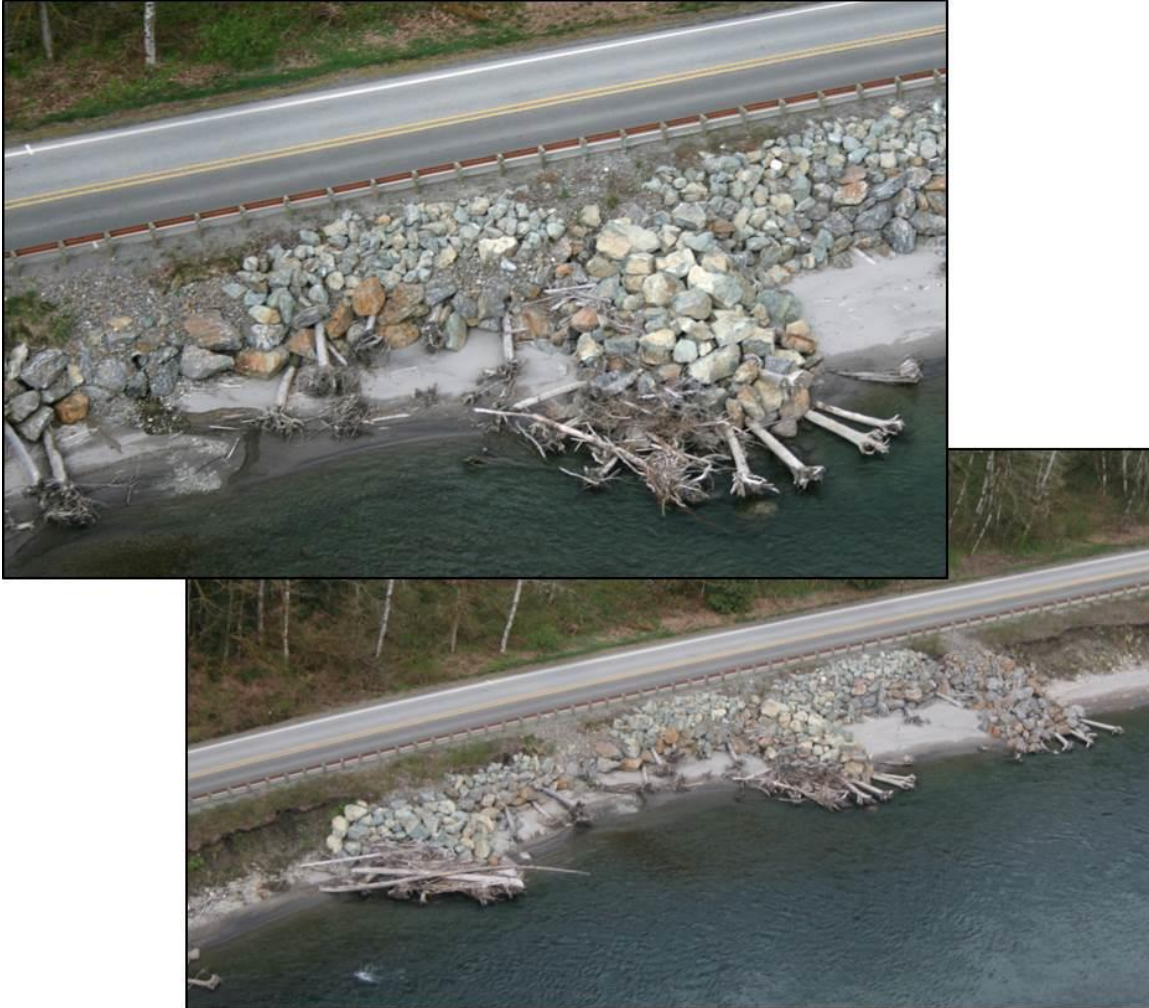
Similar modifications have been made to upstream Groins 3-8 (Figures 7 and 8). These groins are made primarily of large rock, with numerous rootwads buried in the rock matrix and projecting out from the edges of the groin to maximize roughness and wood recruitment. These structures create flow complexity, eddy resting habitat, and cover. Habitat impacts include loss of aquatic habitat under the footprints of the structures.

**Figure 7. Groins and Roughened Log and Rock Toe upstream of Groin 9, 2009.**

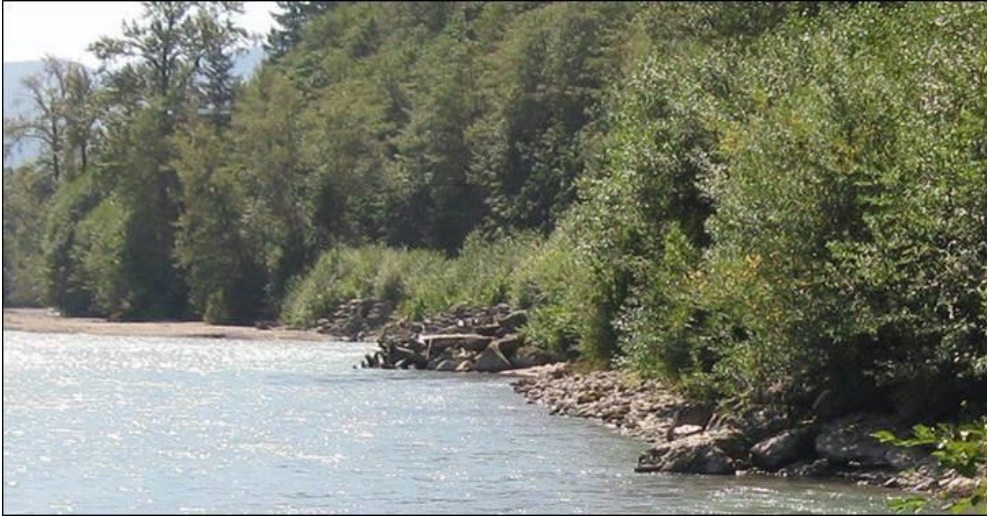
**Figure 8. Groins and Roughened Log and Rock Toes after revegetation, August 2014.**

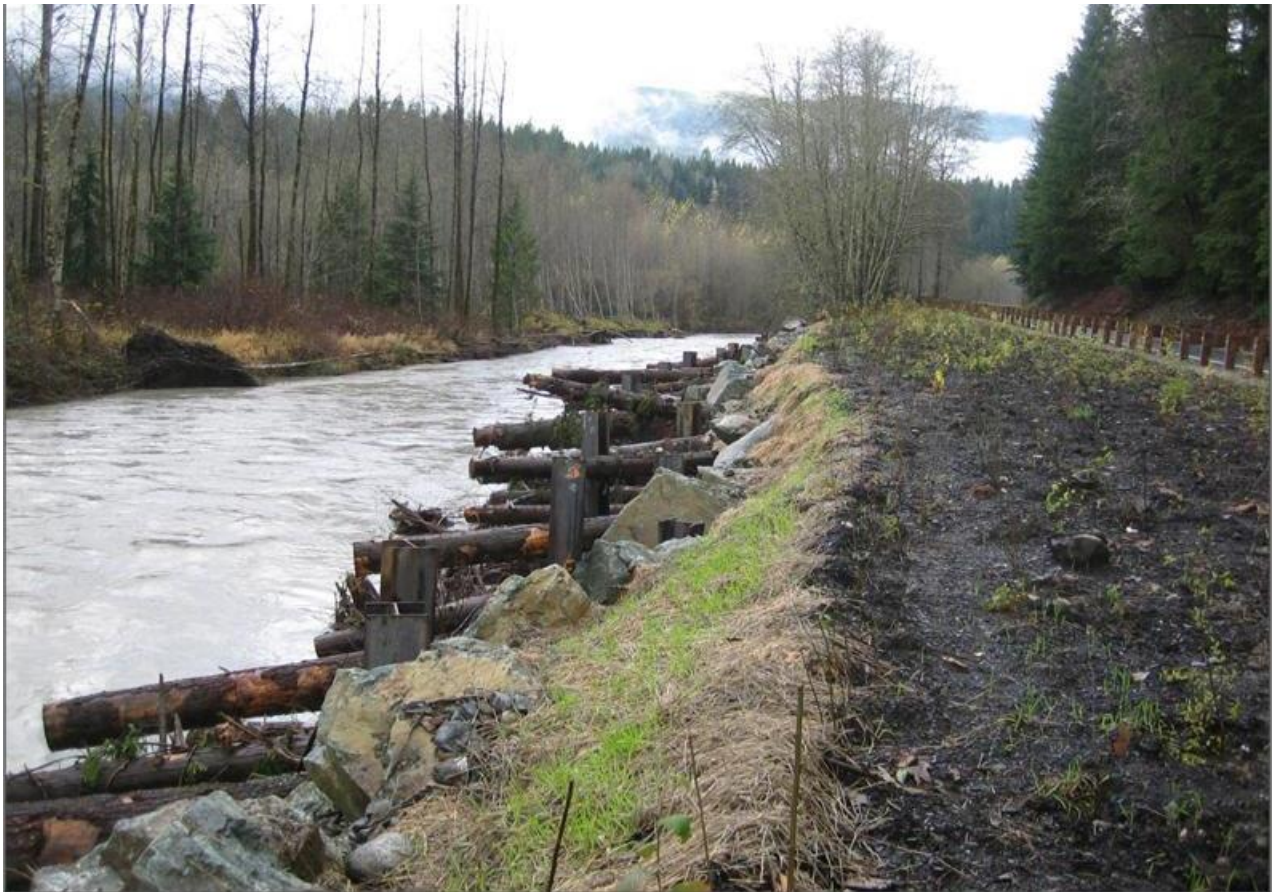
**Figure 9. Pile-anchored cribwall at SR 530 MP 59.2.**

A pile-anchored cribwall would be constructed along the bank between Groins 9 and 11, similar to an existing cribwall constructing downstream at MP 59.2 (Figures 9 and 10). The cribwall would be constructed by driving piles offshore and wedging rootwads and logs among the piles. Layers of logs would then be buried with rock, soil, and slash, and the top of structure would be planted with riparian trees and shrubs. This would provide a reinforced riparian buffer with high roughness and erosion resistance.

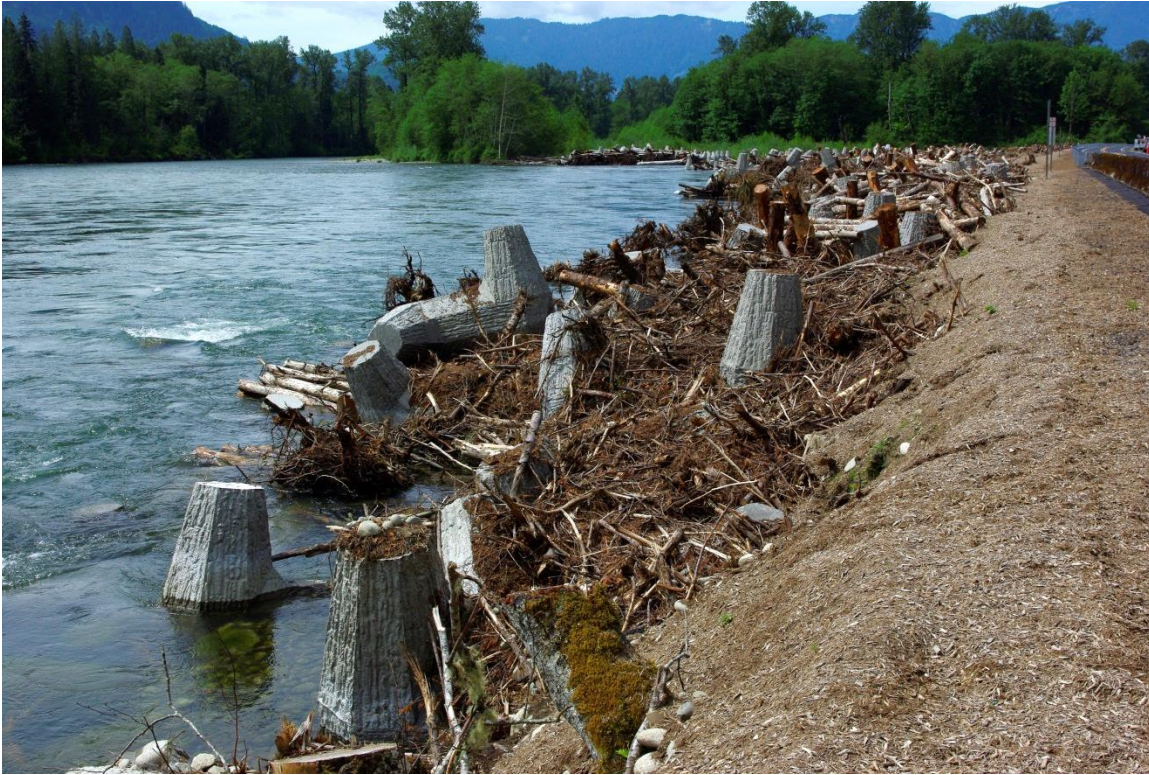
**Figure 11. Example of a dolo-reinforced log terrace protecting SR 20 on the Skagit River (Alternative 4).**

This alternative would construct a reinforced riparian buffer between Groins 9 and 11, similar to Alternative 3. However, the bank in this case would be reinforced by placing interlocking clusters of logs anchored with concrete dolos. The area behind the log and dolo clusters would be filled with rock, slash, and soil, and planted with riparian trees and shrubs. This type of treatment was recently constructed on the Skagit River to protect SR 20 (Figure 11).
